# Manhole Inspection Summary

Manhole # S31G\_\_014MH

Insp Date: **8/1/08 10:06 AM**

**Location** Address: **400 w redwood st**

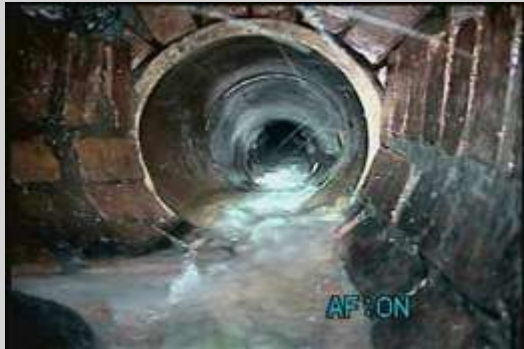
12 O'Clock Outflow

10 in. Circular Gravity Sewer  
Pipe Out @ 12 O'Clock

Pipe Material: **Clay** ☐ Pipe Lined

Invert Depth: **15.16** (ft.) Flow Characteristics: **Fast**

Deposits: ☒ None ☐ Mud ☐ Sludge ☐ Debris ☐ Grease

Infiltration: **None** Pipe Seal Cond: **Unknown**

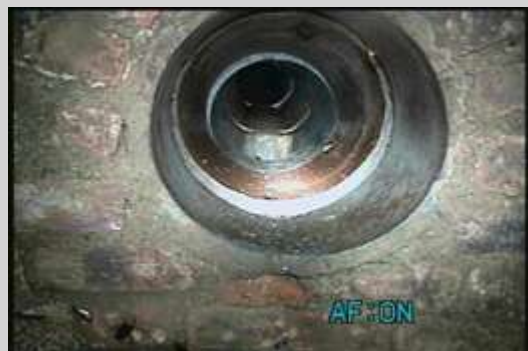
9 O'Clock Inflow

10 in. Circular Gravity Sewer  
Pipe In @ 9 OClock

Pipe Material: **Clay** ☐ Pipe Lined

Infiltration: **None** Pipe Seal Cond: **Unknown**
